OCU-HEP 2002-01

AFM pictures of the surfaces of glass RPC electrodes damaged by water vapor contamination

T. Kubo, E. Nakano and Y. Teramoto

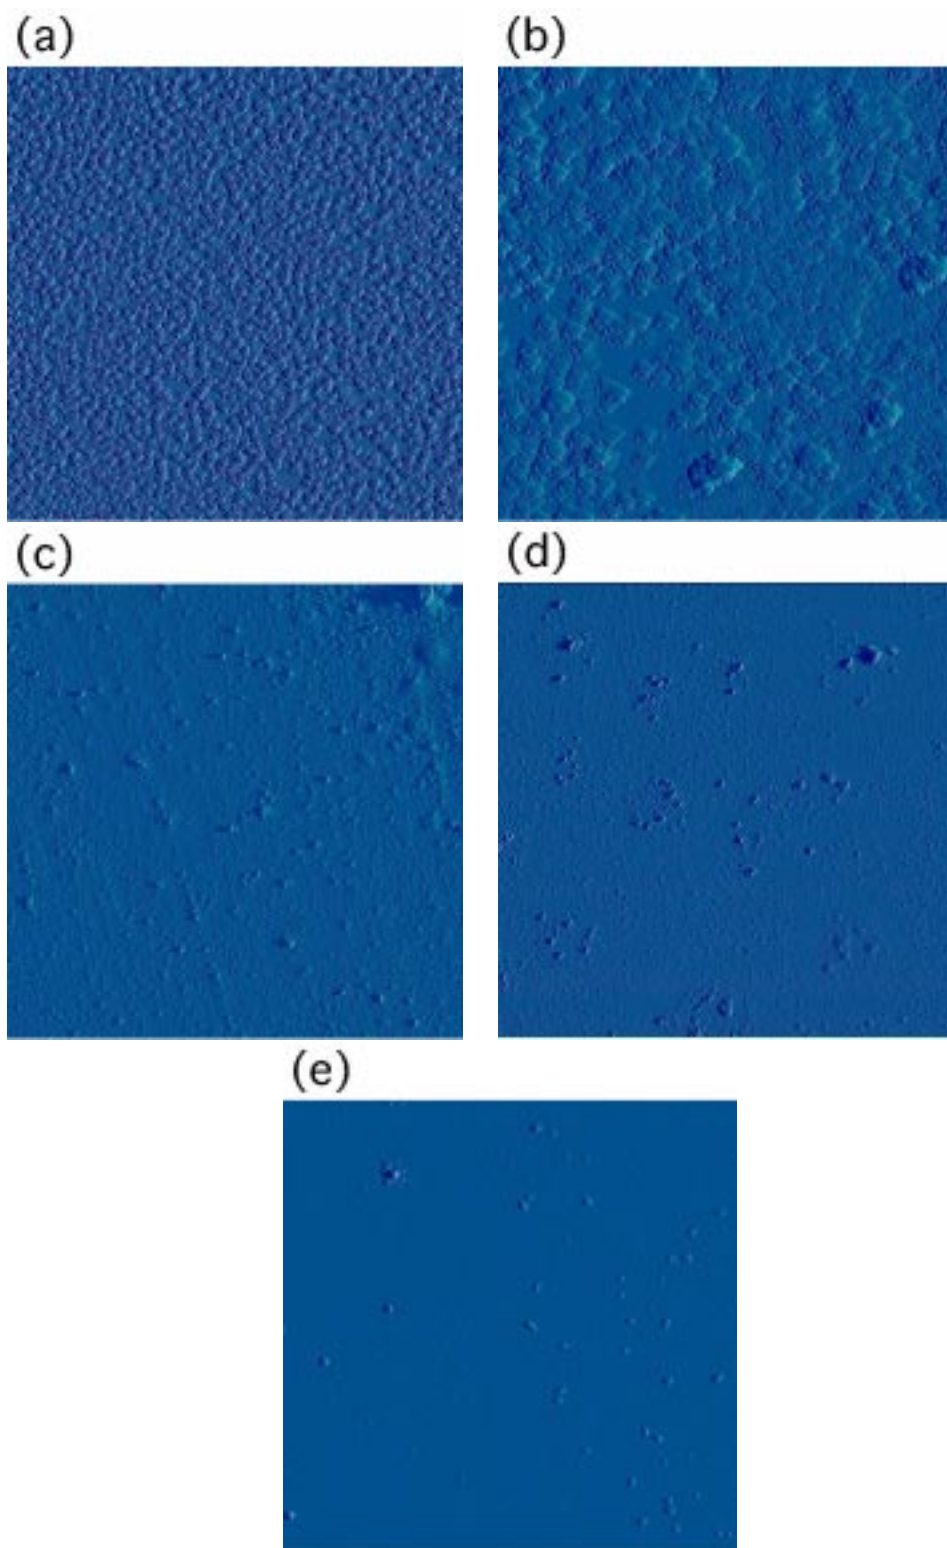
The AFM pictures of the glass surfaces are shown in Fig. 1. In the freon operated chamber, substances of $0.05\text{ }\mu\text{m}$ in diameter and 100 nm thickness are seen on the anode. On the cathode, larger diameter ($0.08\text{ }\mu\text{m}$) and irregular shaped substances are seen. We consider the substances as deposits on the glass based on these pictures. This explanation is also supported by the fact that the damaged electrodes can be recovered by scrubbing them using paper dipped in alcohol (2). In the freonless chamber, the observed substances are much smaller ($0.005\text{ }\mu\text{m}$), both on the anode and cathode.

In conclusion, the AFM picture clarified the scenario of GRPC damage; when glass RPCs are operated in the streamer mode in a chamber gas containing freon and operated under water vapor-contaminated conditions, deposits are formed on both the anode and the cathode surfaces. These substances reduce the work-function of the electrode surfaces, leading to the field emission of electrons from the cathode. This reduces the electric field inside the chamber below the efficiency plateau and causes a permanent efficiency drop.

Figure 1: AFM pictures of glass surfaces. (a) anode (freon), (b) cathode (freon), (c) anode (freonless), (d) cathode (freonless), (e) brand new glass. The size of each frame is $10 \times 10 \mu\text{m}$.
